WASBO Spring Conference

Bay Lane Elementary Recovery of the Year 2023

The 2023 Emergency Fire Restoration of Bay Lane Elementary School

2023 WASBO Recovery of
the Year Award Winner

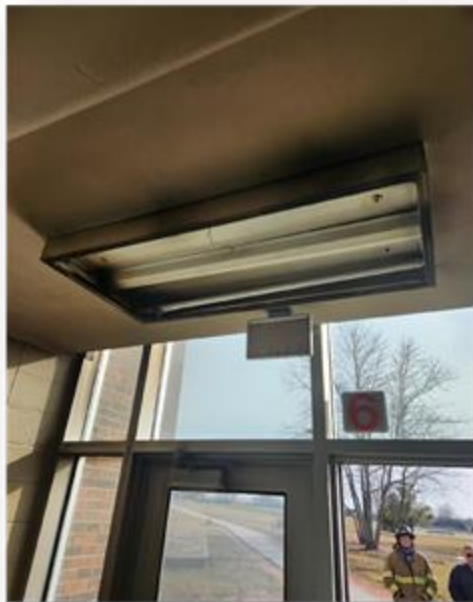
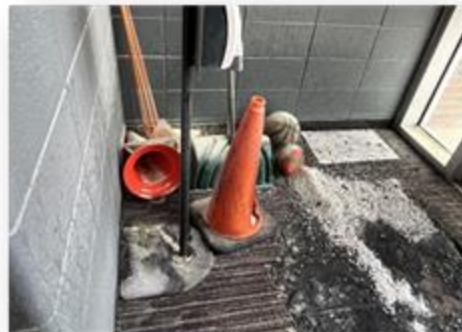
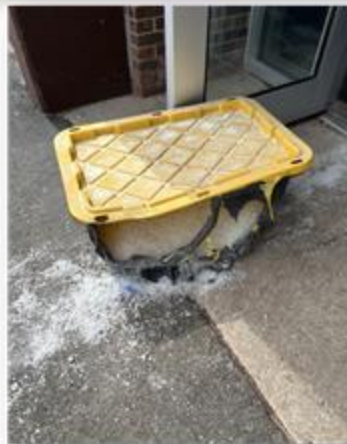
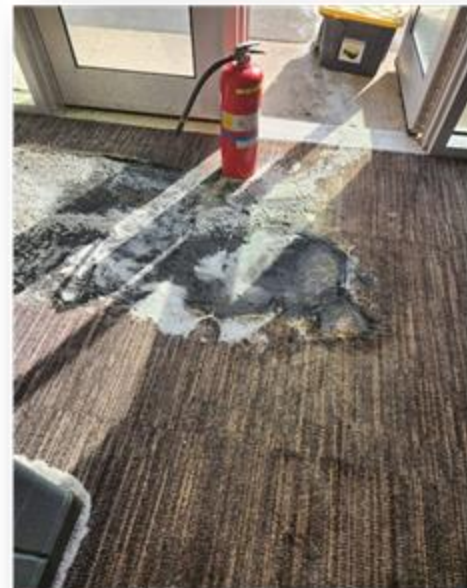
It was apparent that the electrical malfunction occurred within the vestibule light fixture. Burning electrical components dropped, causing items on the ground to ignite.

While the physical fire damage was contained to a relatively small area, the smoke damage to the school was extensive. Below were the initial steps taken:

- The source area was immediately secured. This was a fire scene, and a cause and origin investigation would need to take place.
- The vestibule was placed under negative air pressure to prevent further odor from traveling into the school.
- An assessment was made by Kelmann Restoration and Environmental Management Consulting as to the extent and depth of smoke damage.
- An initial scope of work was developed and relayed to both the district and the district's insurance carrier's representative, LJ Shaw.

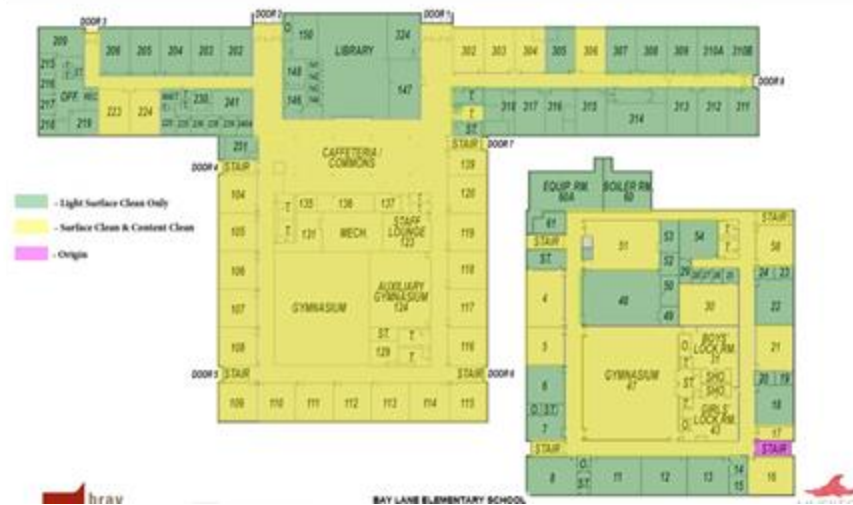
This is a color-coded, scope of work chart that visually defines the extent and concentration of smoke damage.

The following was determined:

- The level of soot infiltration was drastically different within different segments of the school.
- Levels of mitigation techniques would be unique to these segments based on EMC's findings.

- The HVAC system was not impacted.
- A re-opening in 8 days was feasible.
- One shift of approximately 85 cleaning technicians would be required. Teams would be comprised of 10-12 members.

- HEPA air scrubbers with charcoal filters and hydroxyl generators would be deployed to address the ambient smoke odor. The number of units was formulated utilizing industry standards.

- Most contents would be cleaned on site. Only textiles and some technology equipment were packed out for offsite cleaning.
- Ceiling tiles in the hallways and rooms directly adjacent to the origin area on both levels would be removed and replaced.

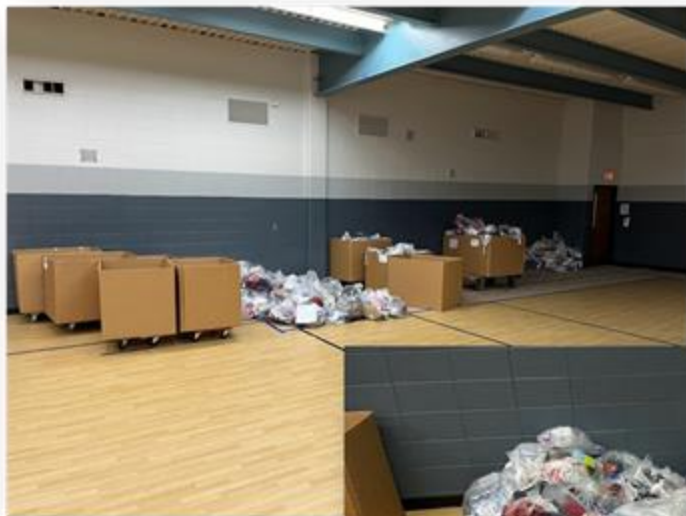
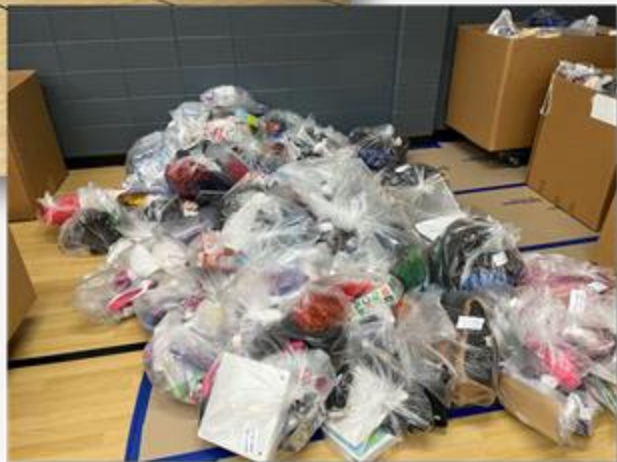
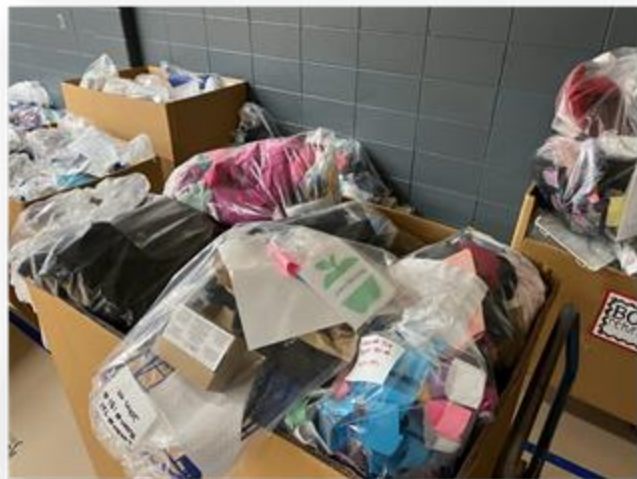
Student's impacted and inventoried locker contents – labeled

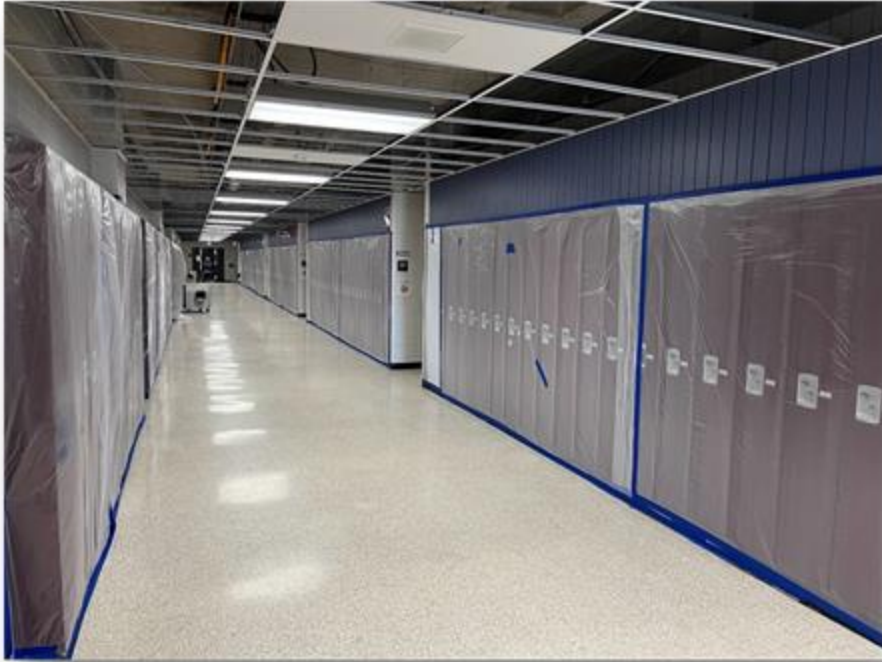
More of the impacted, inventoried and labeled student locker contents. The district instructed Kelmann to dispose of it after consultation with insurance and parents.
