Storm Water Practice Maintenance

POND INSPECTIONS

Mark Bruns, CISEC

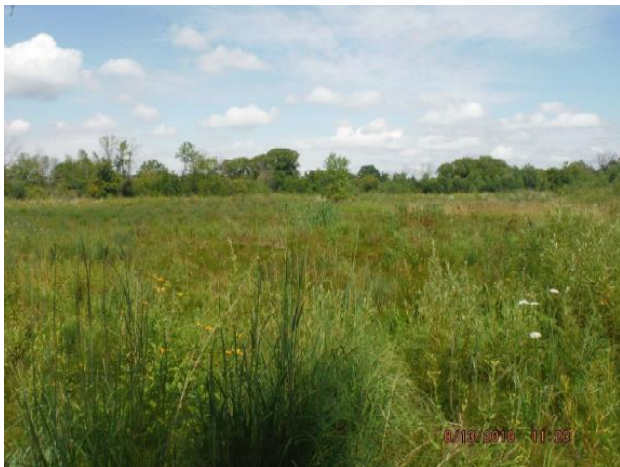
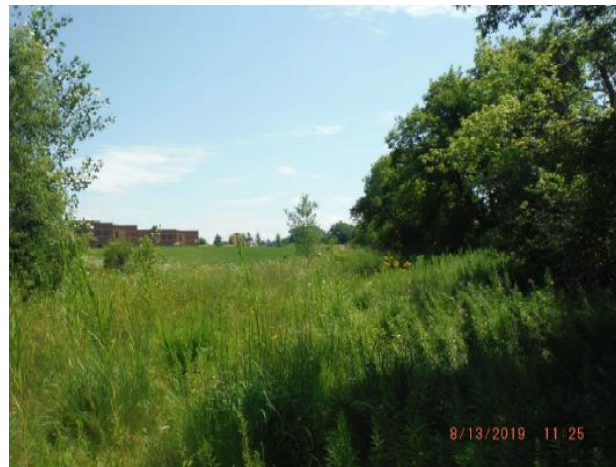
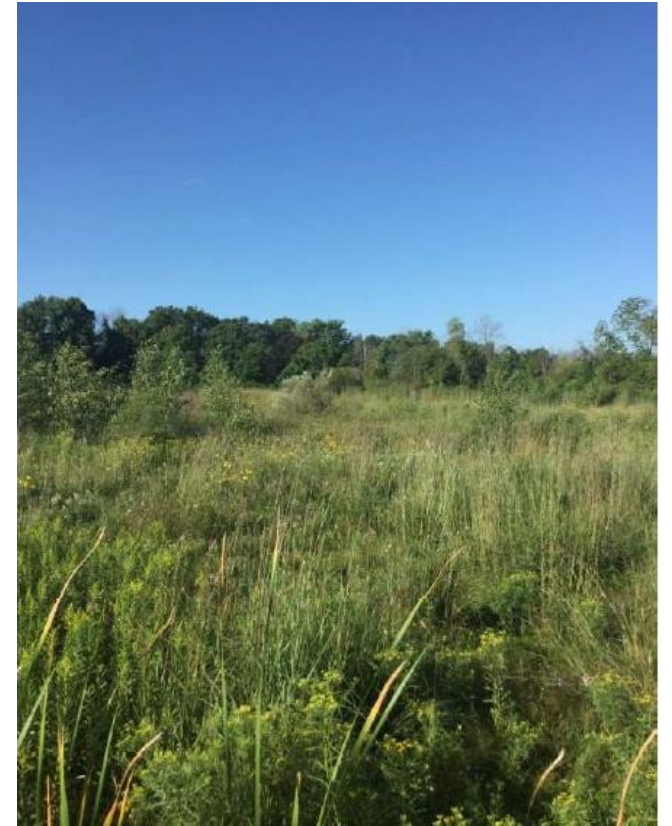
■ Cattails Present

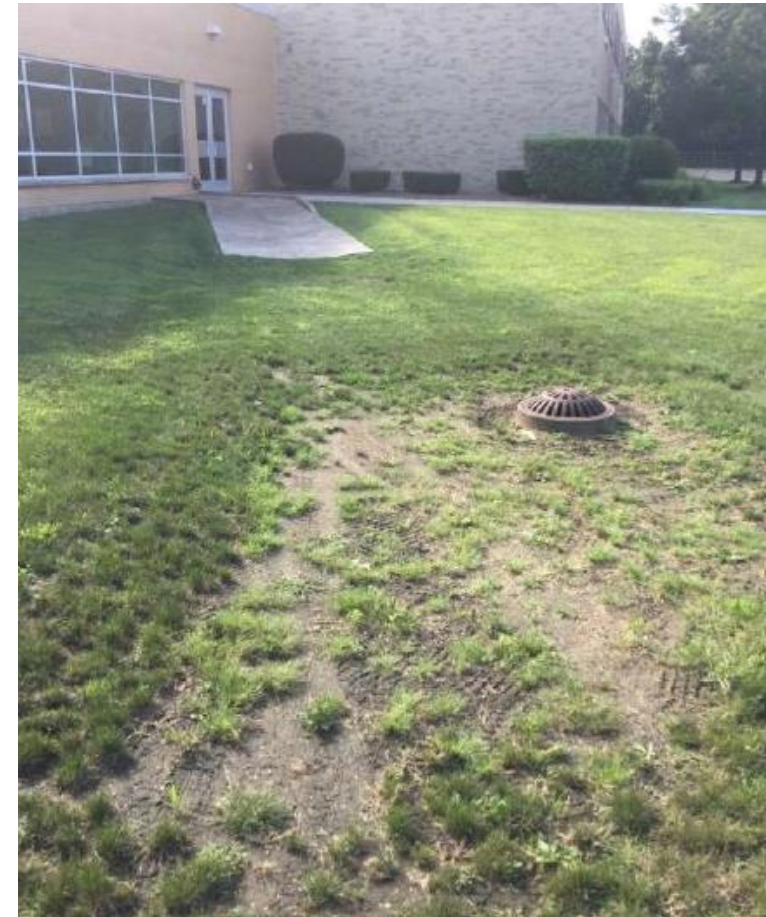
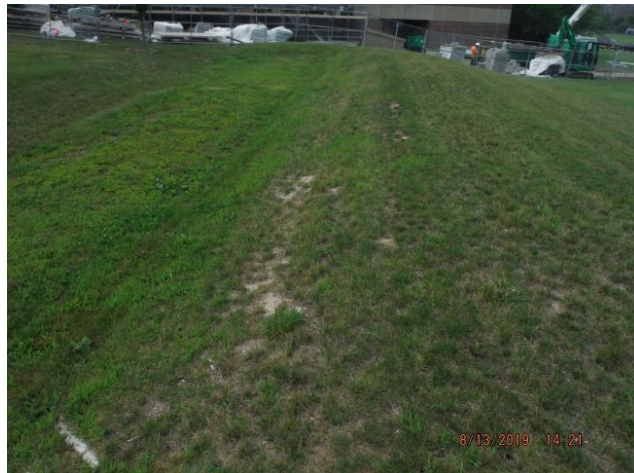
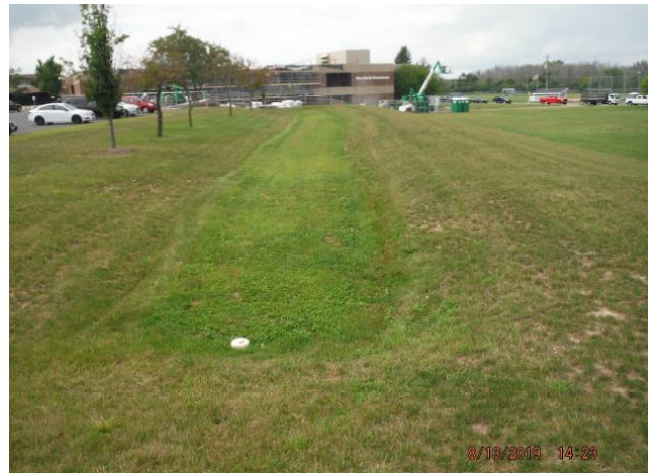
- Patchy vegetation can be an indicator of flooding or standing water.

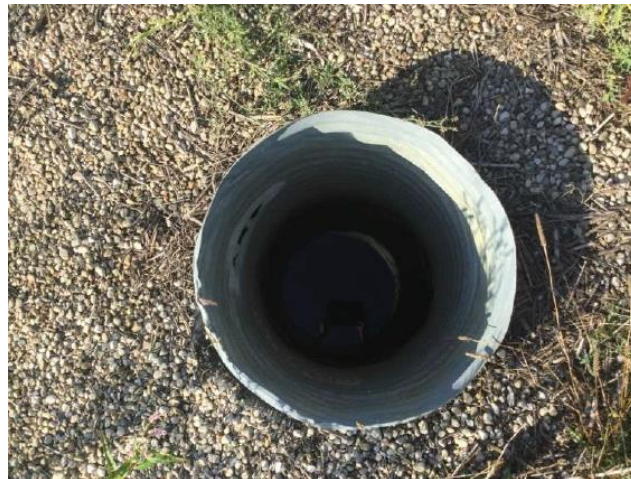
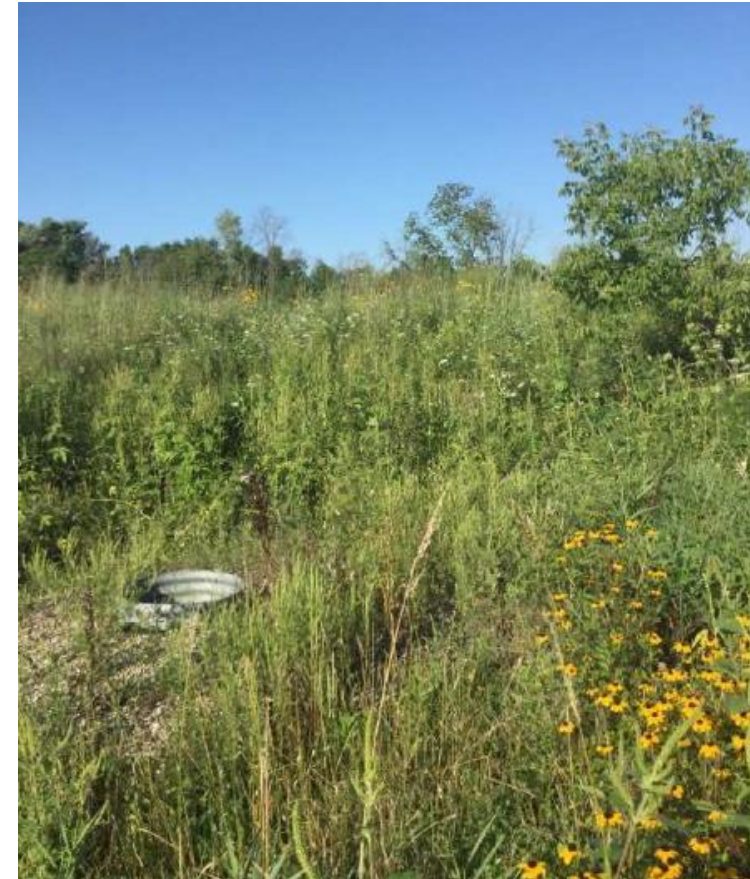
- This dry pond had an unusual looking riser pipe. No grate or trash rack

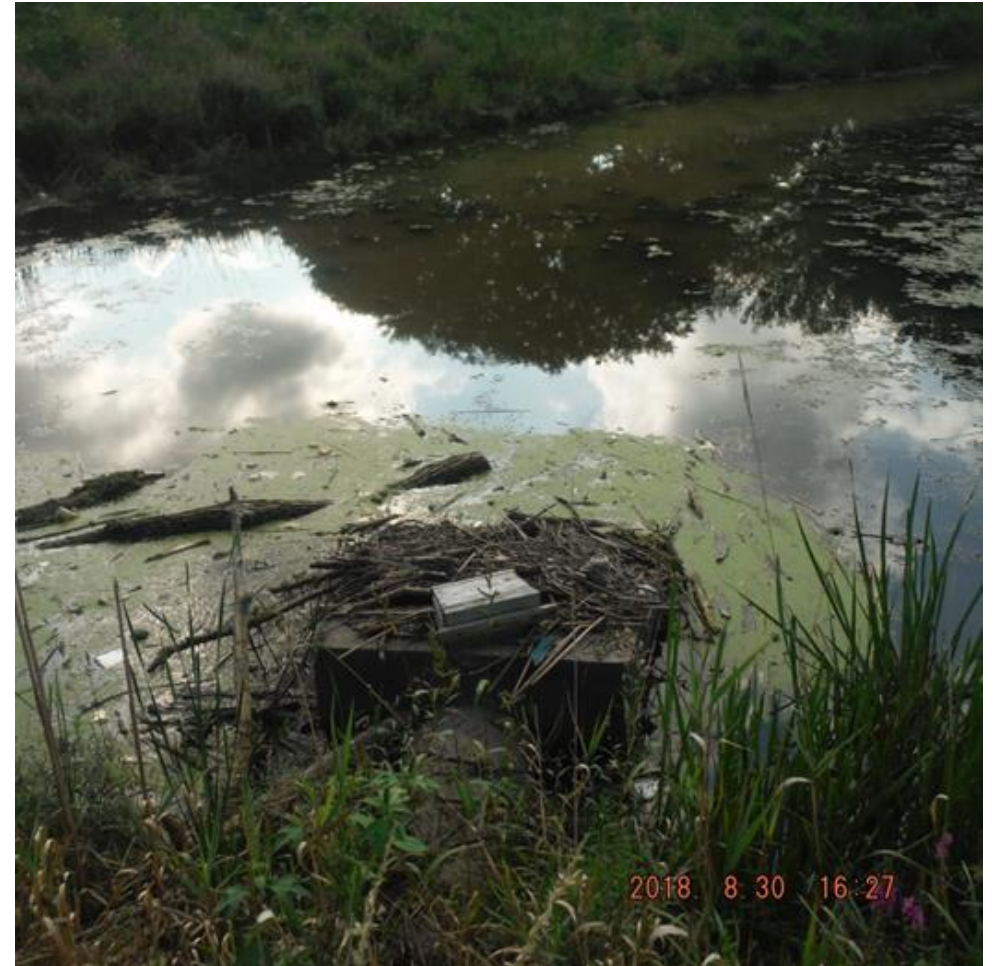
- This outlet structure has obstructions on the top of the overflow and algae and logs around the structure. This along with vegetation can block the structure orifices.

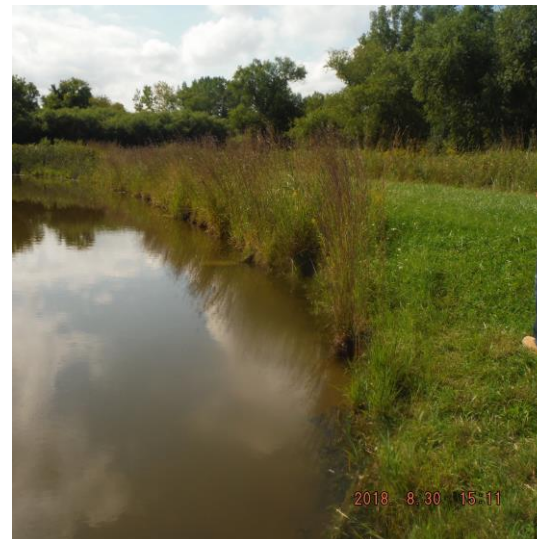
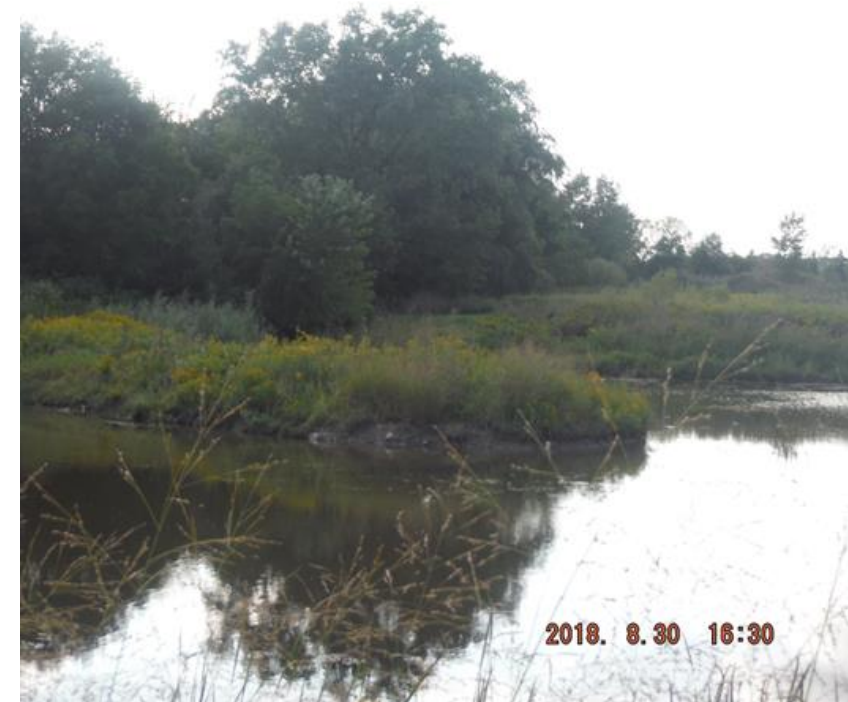
- We look for erosion occurring along the bank
- Wave action is occurring

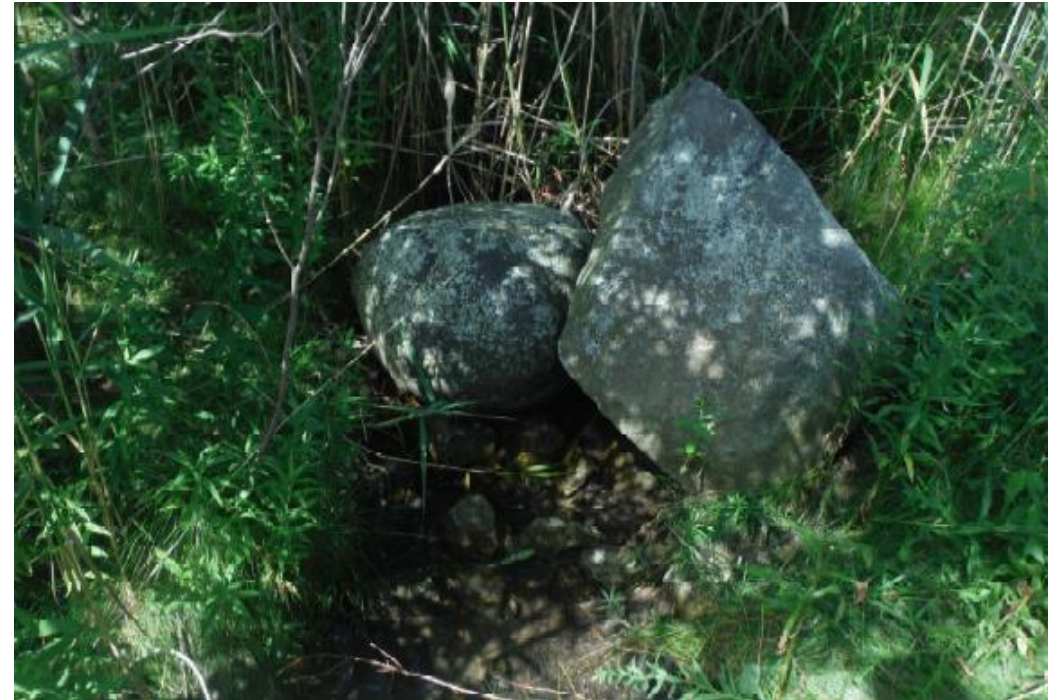
■ Rocks obstructing inlet pipe

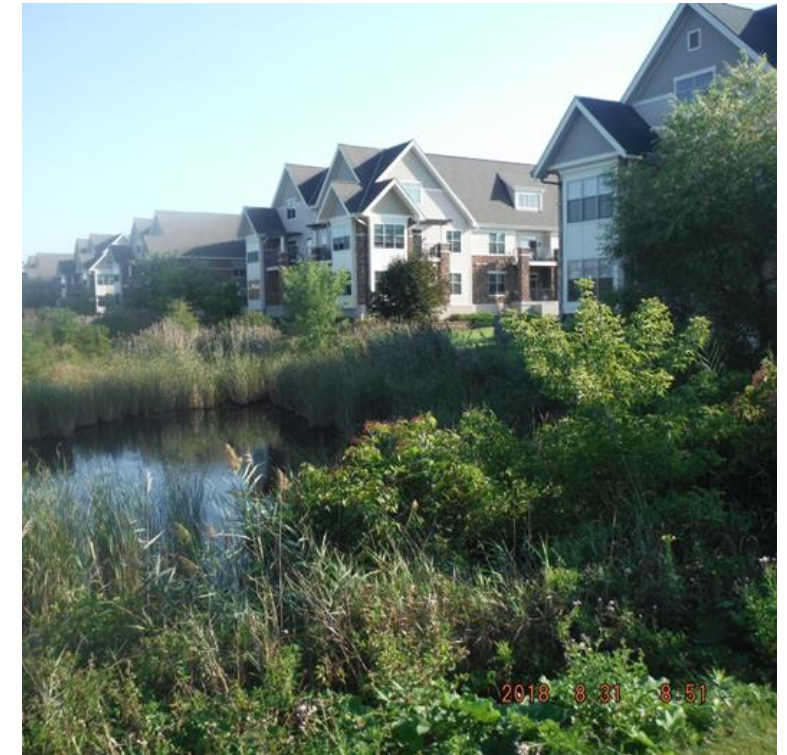
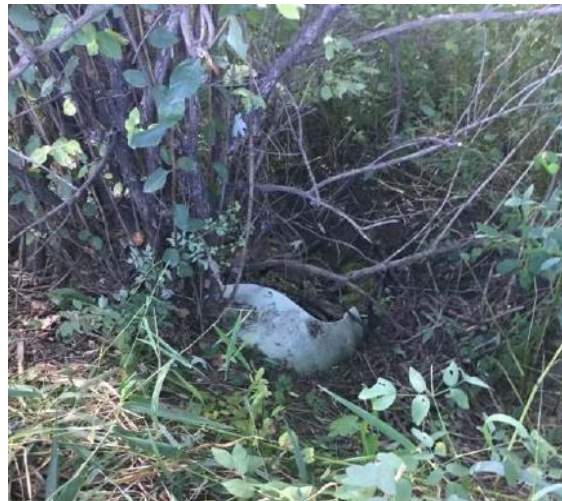
- Heavy vegetation along the pond side slopes makes it difficult to inspect and requires more work to bring it into compliance
- Woody growth at inlet pipe

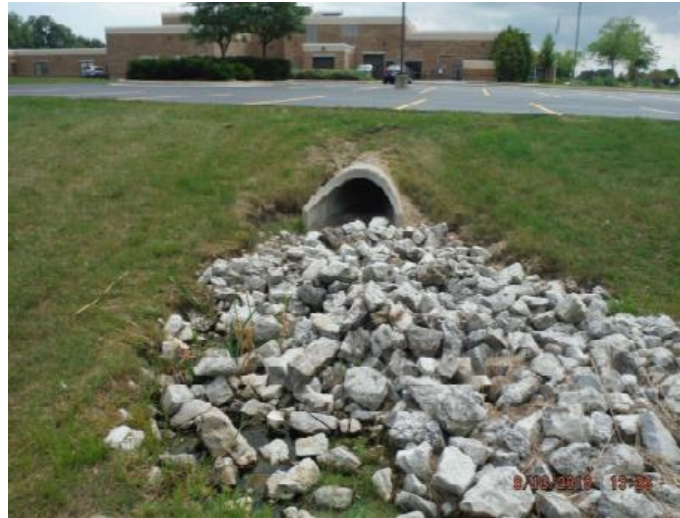
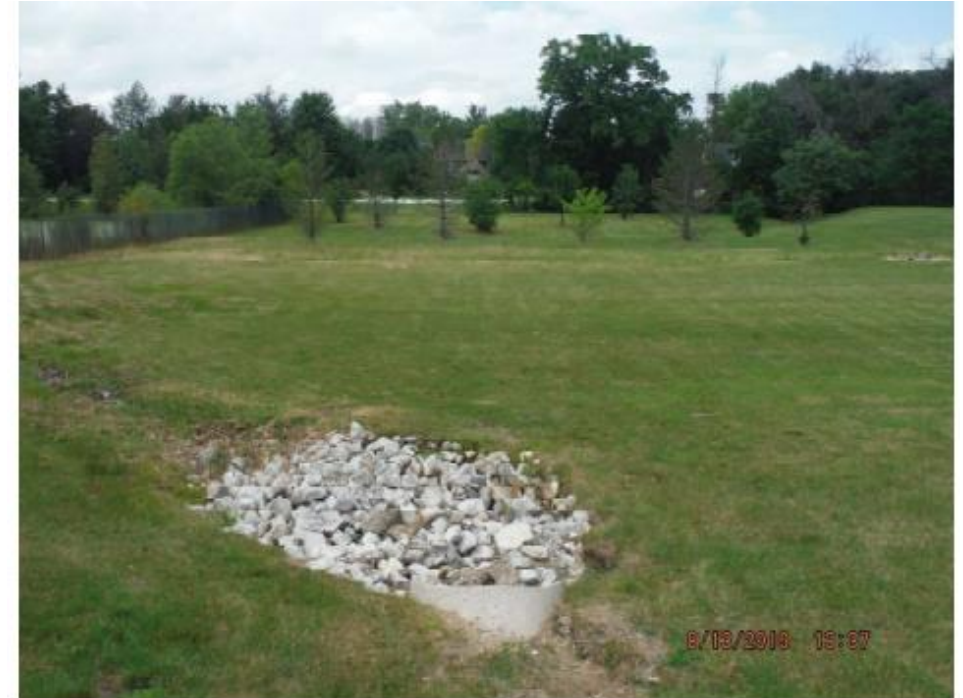
- Sediment Forebay – with erosion at the south inlet flowline

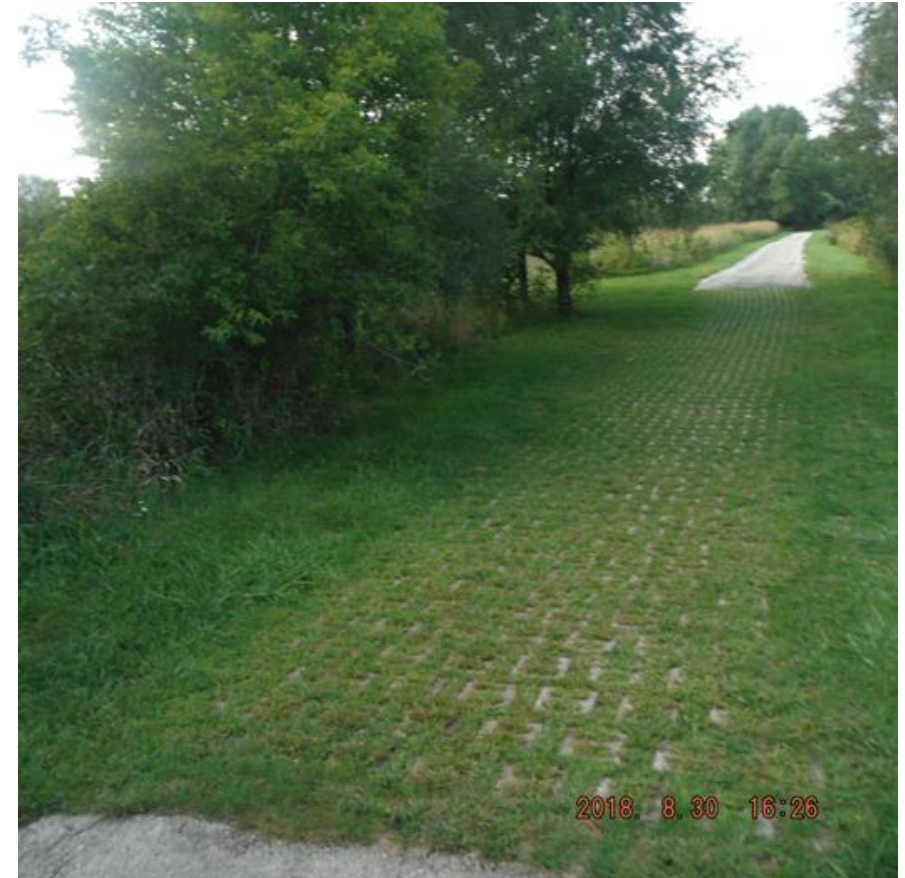
- Trees and other woody growth may impede the flow and its root system may affect the integrity of the spillway.

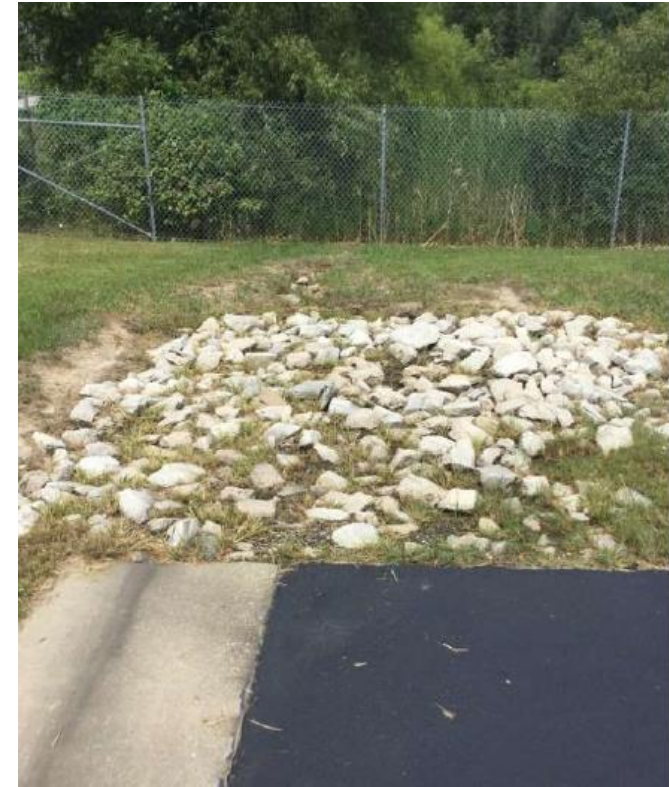
- Erosion along and downstream of riprap at inlet swale

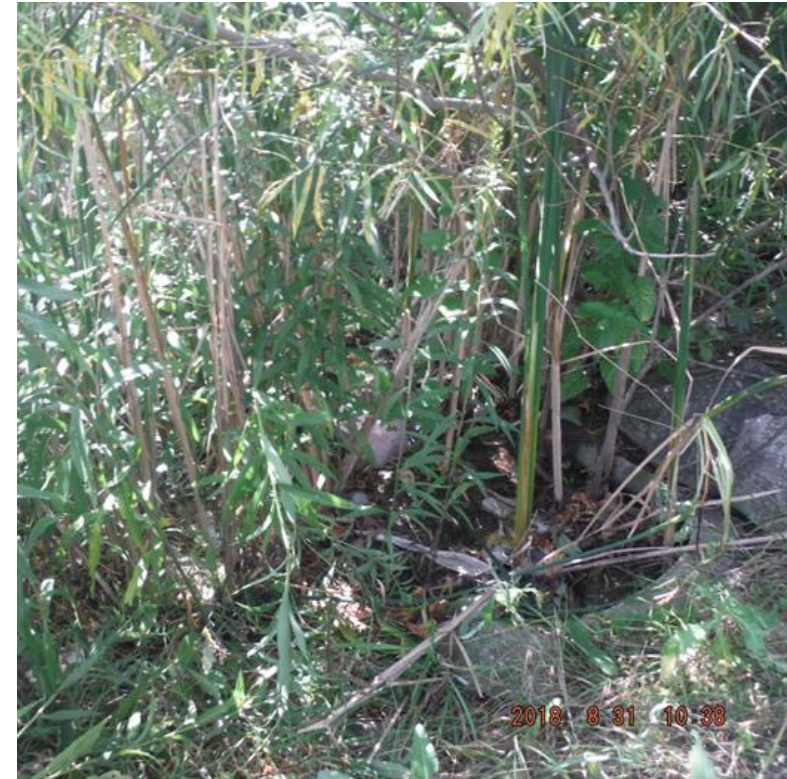
- Sediment and heavy vegetation at and in the inlet pipe to the pond

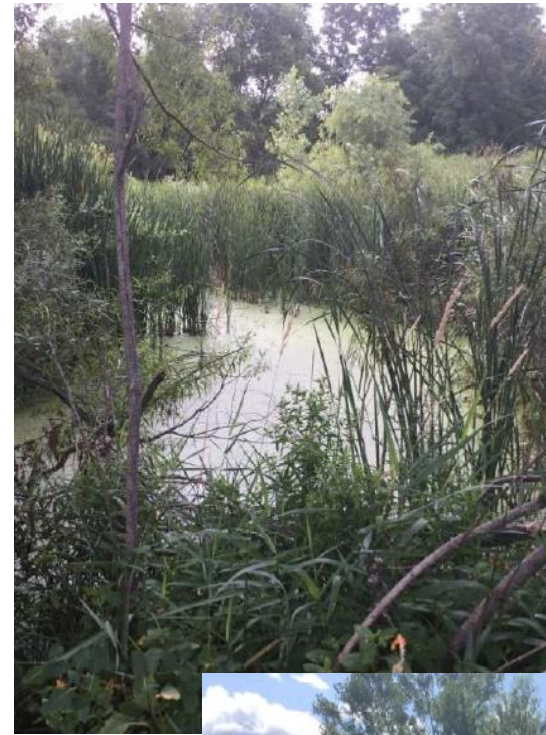
Severe issues through out

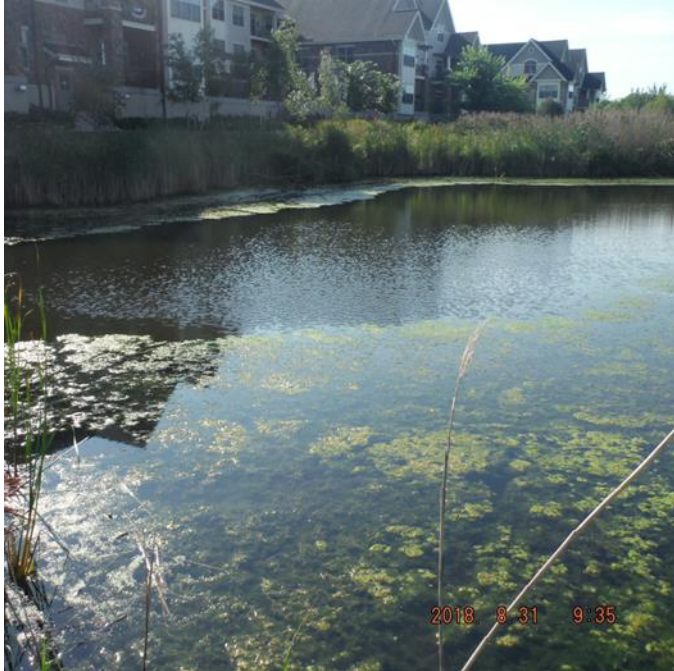
- Excessive algae is present

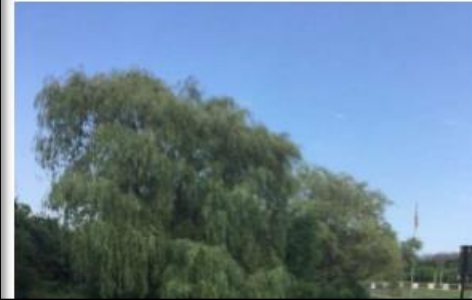
Eisenhower - Device #1 - Overflow area north of the wet pond.

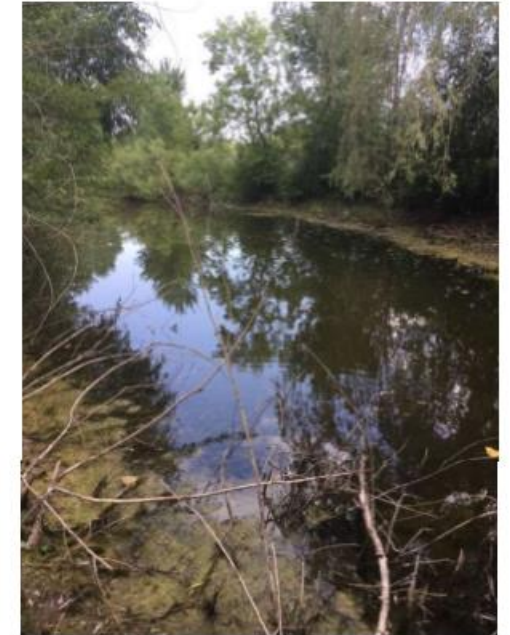
- **The pond embankment** has thick vegetation (not all desirable), small trees and brush further up on the embankment above the typical high-water elevation. Consider removing growth in accordance with the maintenance agreement and mowing the remainder of the embankment in accordance with the maintenance agreement at a height of 5 to 8 inches.
- **The outlet pipe** should have vegetation removed from around it. There is also some erosion occurring at the end of the outlet pipe. Repair erosion and place rip-rap to help dissipate velocity and prevent additional erosion in the future.
- **The water surface** has some very minor algae. The report recommends removal of algae once that

Eisenhower - Device #1 - Facing east across the device. Algae is present.
