WASBO Spring Conference

Bay Lane Elementary Recovery of the Year 2023

The 2023 Emergency Fire Restoration of Bay Lane Elementary School

2023 WASBO Recovery of
the Year Award Winner

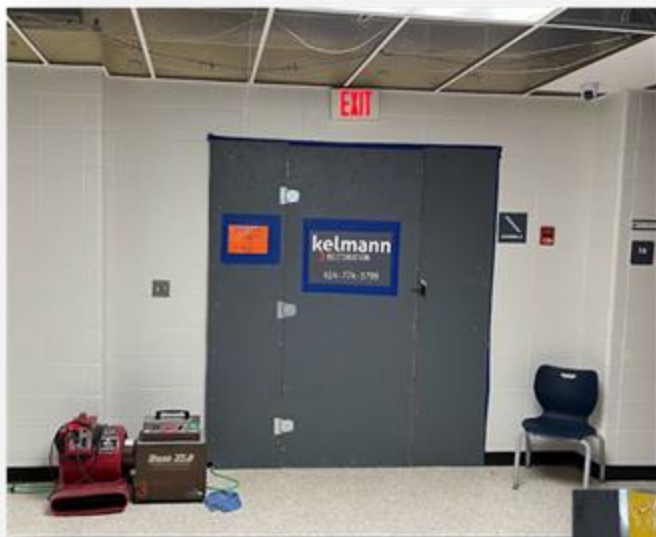
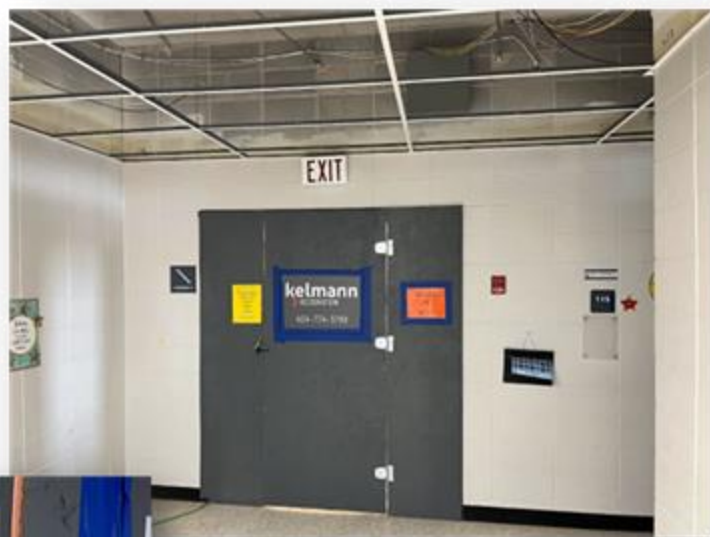
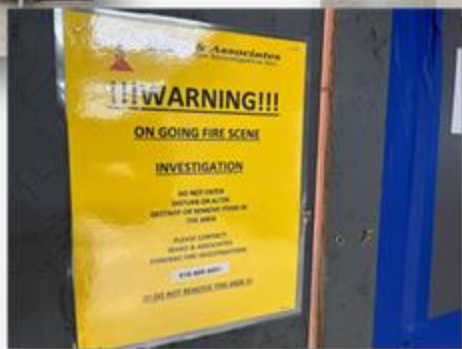
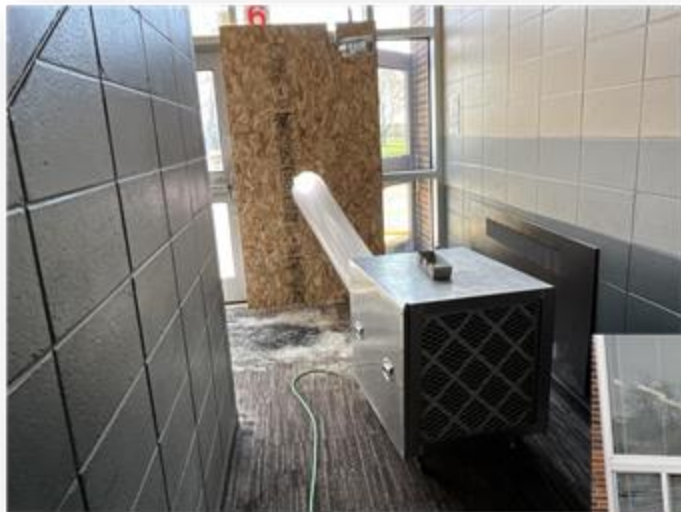
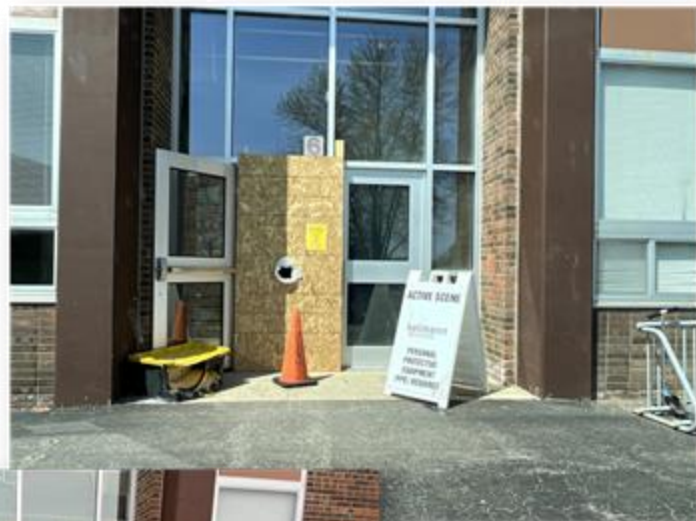
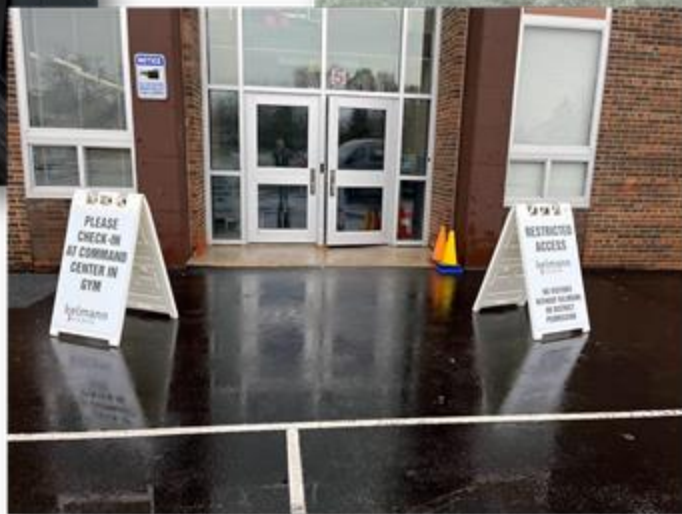
It was apparent that the electrical malfunction occurred within the vestibule light fixture. Burning electrical components dropped, causing items on the ground to ignite.

While the physical fire damage was contained to a relatively small area, the smoke damage to the school was extensive. Below were the initial steps taken:

- HEPA air scrubbers with charcoal filters and hydroxyl generators would be deployed to address the ambient smoke odor. The number of units was formulated utilizing industry standards.

- Most contents would be cleaned on site. Only textiles and some technology equipment were packed out for offsite cleaning.
- Ceiling tiles in the hallways and rooms directly adjacent to the origin area on both levels would be removed and replaced.

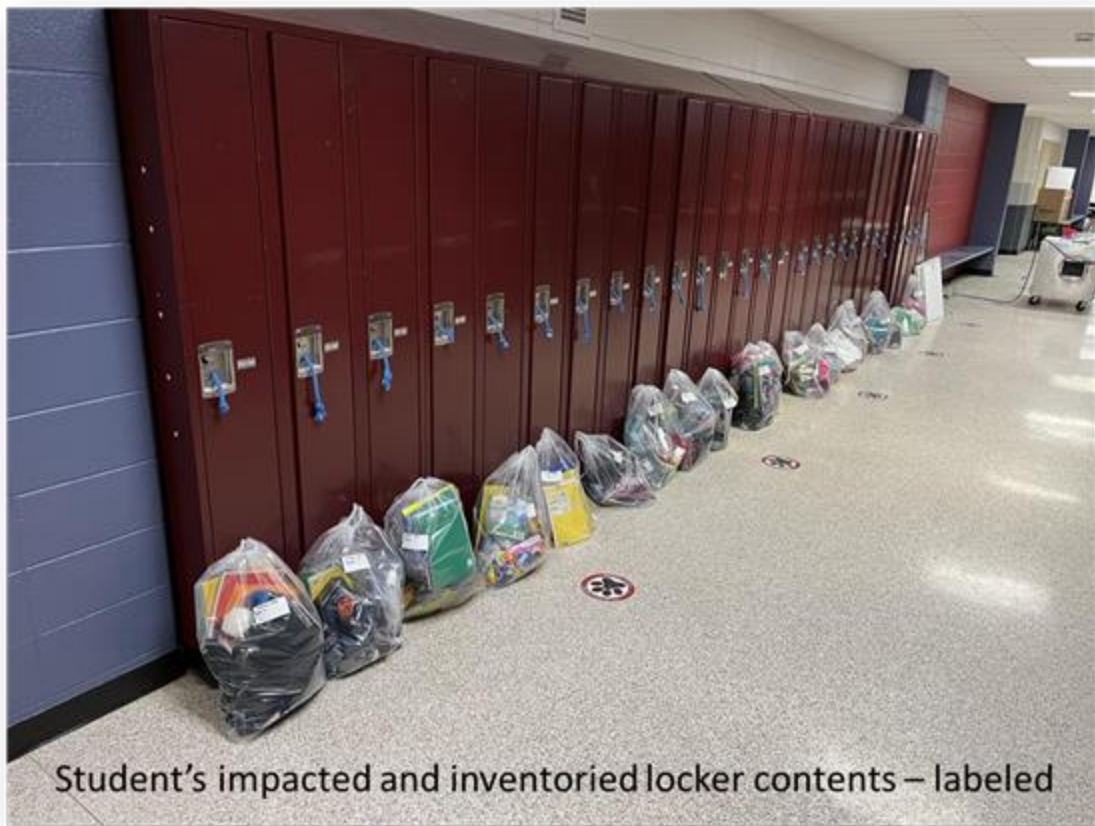
Student's impacted and inventoried locker contents – labeled

More of the impacted, inventoried and labeled student locker contents. The district instructed Kelmann to dispose of it after consultation with insurance and parents.
